Re: Hazardous Materials Survey of the Ketchikan Pioneer Hall

On 6 May 2022, I performed a hazardous materials inspection of the Ketchikan Pioneer Hall in Ketchikan, Alaska, as part of planning for renovation of the building.

Project Name/Location: Ketchikan Pioneer Hall Hazmat Survey

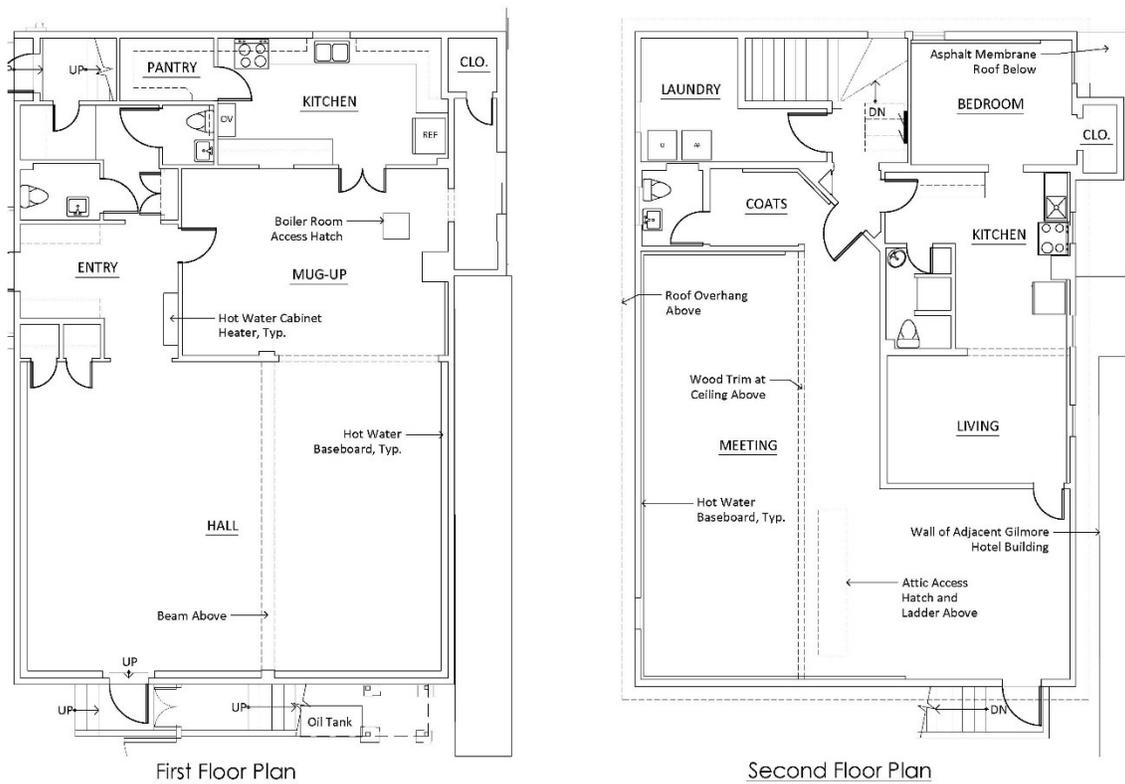
FIGURE 2. Ketchikan Pioneer Hall Interior Layout

The building is heated via an oil-fired boiler located in a mechanical room in the crawl space, accessed from the center of the first floor. Hot water is provided from an electric water heater in the same location. The remainder of the crawl space is unfinished. Figure 2 shows the general layout.

The building is a rectangular structure with an interior staircase along the northeast end and an exterior stair along the southwest end. All of the first floor and two-thirds of the second floor are meeting spaces, and approximately one third of the second floor houses a one-bedroom apartment.
